TECHNICAL NOTE

Analysis and evaluation of stability for the reactivated landslide along deep-seated weakness zones

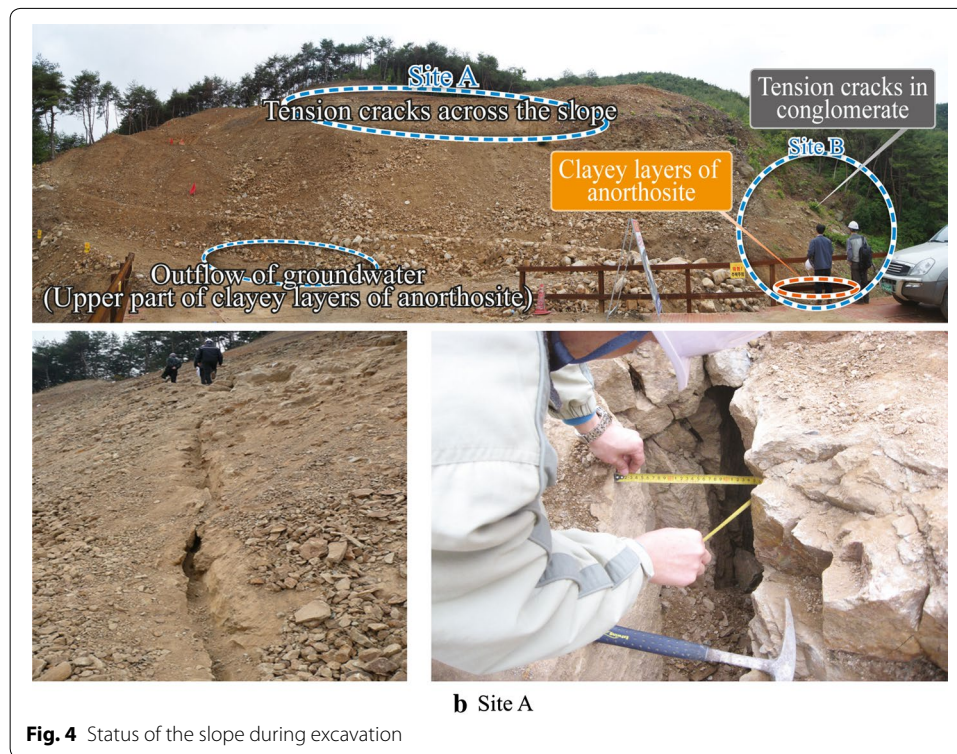
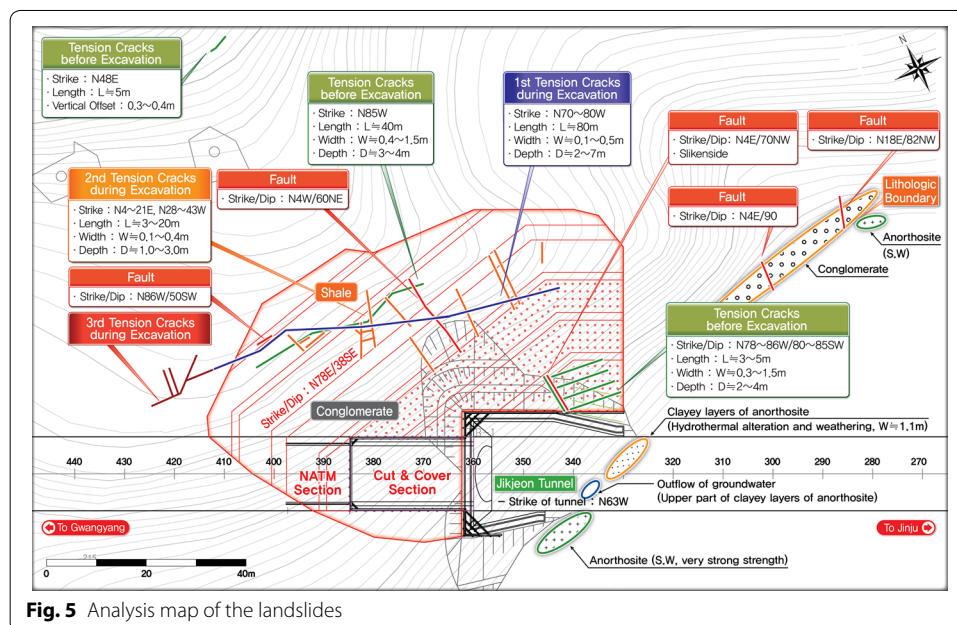
In October 2009, while clearing and grubbing work prior to the construction of the slope at the tunnel portal, tension cracks of 40 m in length and 3 – 4 m in depth were discovered in the upper part of the slope. And several tension cracks caused by movement of rock blocks were found in the lower right-hand side of the slope. Also, protruding rocks, vertical offset and scarps in the natural slope were observed. In spite of additional reduction of slope gradient (1:1.3) to stabilize the slope and to remove the existing tension cracks, subsequent large-scale tension cracks (Width: 0.1 – 0.5 m, Depth: 2 – 7 m)

which stretches about 80 m in length across the slope surface occurred in October 2010. Based on this circumstance, it was estimated that the actual depth of the crack would be much deeper and closer to the lower part of the slope. In addition to the large-scale tension cracks, several other tension cracks (Width: 0.1 – 0.4 m, Depth: 1 – 3 m) occurred, intersecting the existing tension cracks. Following this, the ground deformation including the additional tension cracks (approximately 10 m in length) and the vertical offset by the extension of main tension cracks (Length: 80 m) were discovered. The status of the slope before and during the excavation are presented in Figs. 3 and 4. The analysis map of the landslides is shown in Fig. 5.

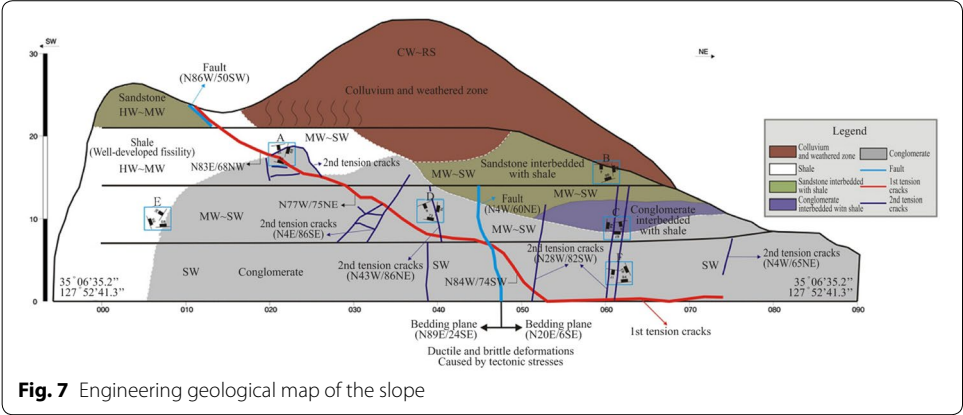
Fig. 7 Engineering geological map of the slope

hydrothermal alteration transformed the upper part of anorthosite into a clay-like soil. The weathered zone of anorthosite exists in the lower right-hand side of the slope. The fault zone and the lithologic boundary between basal conglomerate and anorthosite were observed in the study area. Changes in geological and geographical environment including groundwater inflow into the unconformity might decrease shear strength along the lithologic boundary. This, in turn, can be assumed to induce the tension cracks in the upper sedimentary rocks. The engineering geological map of the slope is presented in Fig. 7.

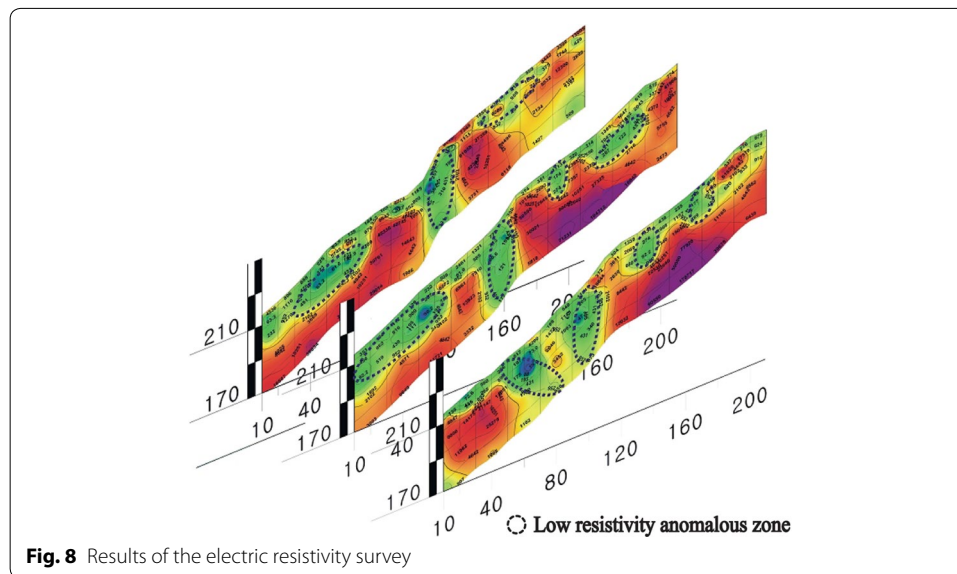
Fig. 8, the low resistivity zone below $500 \Omega\text{m}$ is located from G.L(-) 20 m to G.L(-) 30 m, showing the horizontal continuity which could be a result of the existing fracture zone and the lithologic boundary. Also, the vertical low resistivity zone influenced by tectonic process is located 130 m apart from the center line of the tunnel with a depth deeper than 40 m.

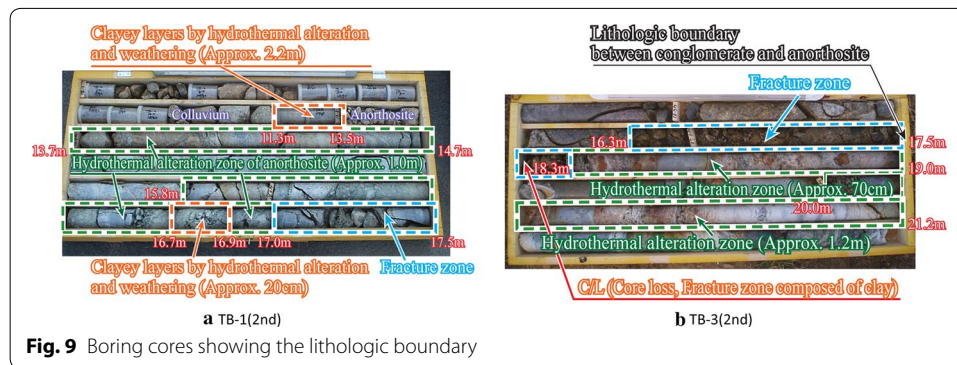
Fig. 9 Boring cores showing the lithologic boundary

During the boring survey, there were several sections where rock cores had not collected. It indicates that there exists fracture or weathered zones formed by highly weathering or tectonic process. Anorthosite is distributed in the lower part of the sedimentary strata. There is a partially fractured zone near the lithologic boundary between the sedimentary rocks and anorthosite. And a number of clayey layers and hydrothermal alteration zones interbedded each other are spread around the boundary. The clayey layers formed by alteration and weathering with the average thickness of 1 – 2 m exists, slanting $10 - 15^\circ$ upward. Anorthosite which showed a good rock quality was distributed in the lower part of the weakness zone. It is found that the fracture zone, the clayey layers and the hydrothermal alteration zone of anorthosite might adversely affect the slope stability. Boring cores showing the lithologic boundary are presented in Fig. 9.

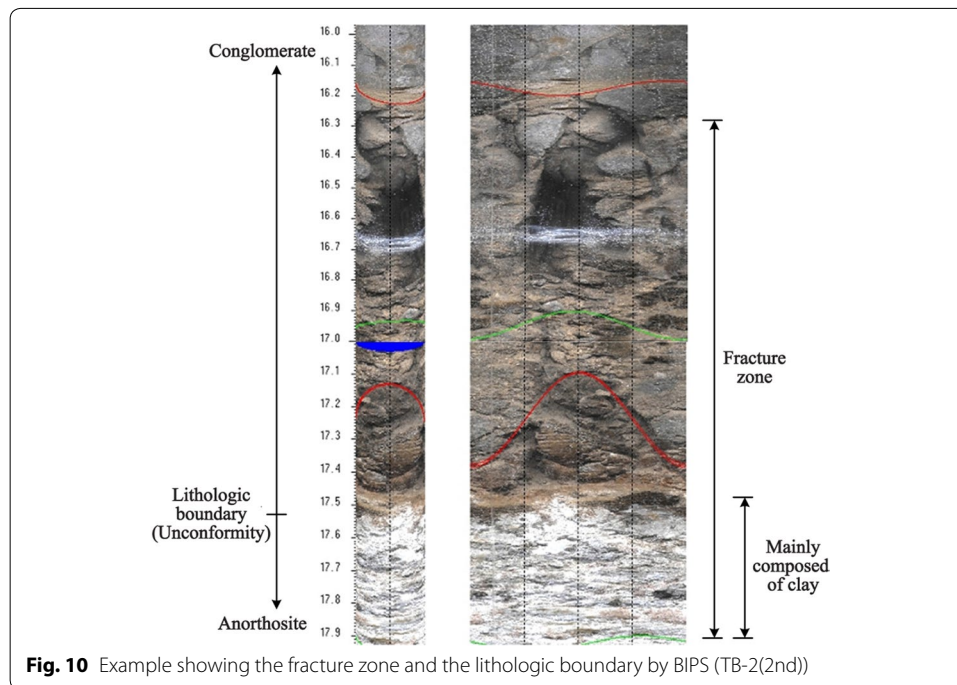
The BIPS was applied to the TB-2(1st), TB-4(1st), TB-1(2nd), TB-2(2nd) and NTB-3(3rd) to determine types of rocks and dominant trends of discontinuities. As a result of the BIPS, it is found that the slope primarily consists of highly weathered and fractured rocks. The dominant dip varies from 10 to 70 degrees, and the dominant space ranges from 60 to 600 mm. In the case of TB-2(2nd), the dominant dip is mainly presented around 30 – 40°, and the joint space appears mainly in a range of 200 – 600 mm. During boring for the BIPS, boreholes are collapsed and washed away in the fracture zone developed around the lithologic boundary between conglomerate and anorthosite. Fig. 10 represents results of the BIPS (TB-2(2nd)) showing the fracture zone and the lithologic boundary.

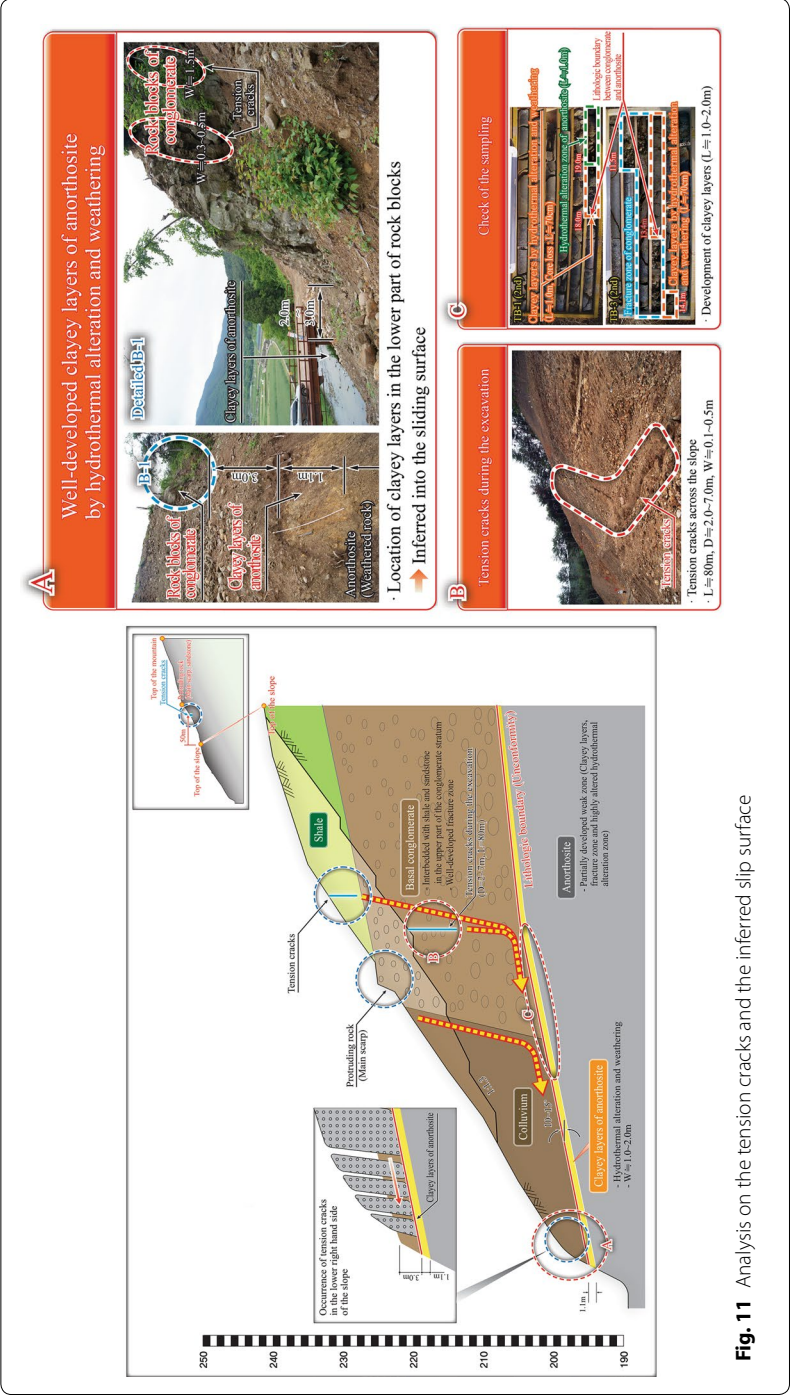
Fig. 11 Analysis on the tension cracks and the inferred slip surface

The inferred slip surface is the weak clayey layers which are developed along the lithologic boundary in the lower part of the slope. The clayey layers were formed due to hydrothermal alteration and inflow of groundwater through the fracture zone, the joints and the bedding plane. A number of tension cracks and scarps were occurred in the upper part of the slope prior to the excavation. The distribution of scarps are similar to

that of the low resistivity zone located 130 m away from the base point of the measurement. The clayey layers caused by alteration and weathering of anorthosite are assumed to be located in the deep-seated failure surface of the tension cracks. It is inferred that the tension cracks by landslides continuously occurred prior to and during the excavation because of increased water pressure, and deterioration of shear strength and frictional resistance along the clayey layers of anorthosite. The analysis results on the tension cracks and the inferred slip surface of the slope are shown in Fig. 11. And the results of the geotechnical investigations and the analysis are presented in Fig. 12.

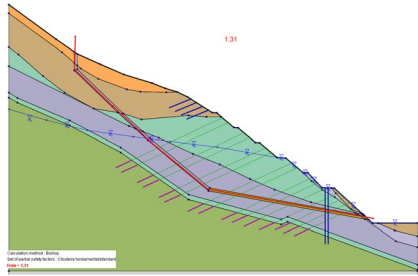
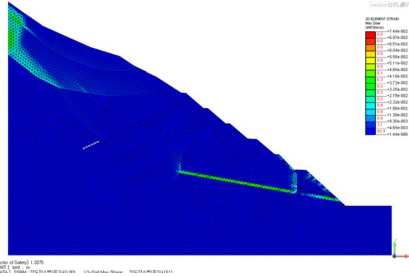
Table 3 Results of the LEM and SRM analysis

FS = 1.31 > 1.3	FS = 1.37 > 1.3
